(Phase I)

Parcel No: SY6-038
20,038 sq. ft. of Vacant Land
11239 Dalebrook/Annunciation Drive
Houston, Texas

Project # 0604161.10

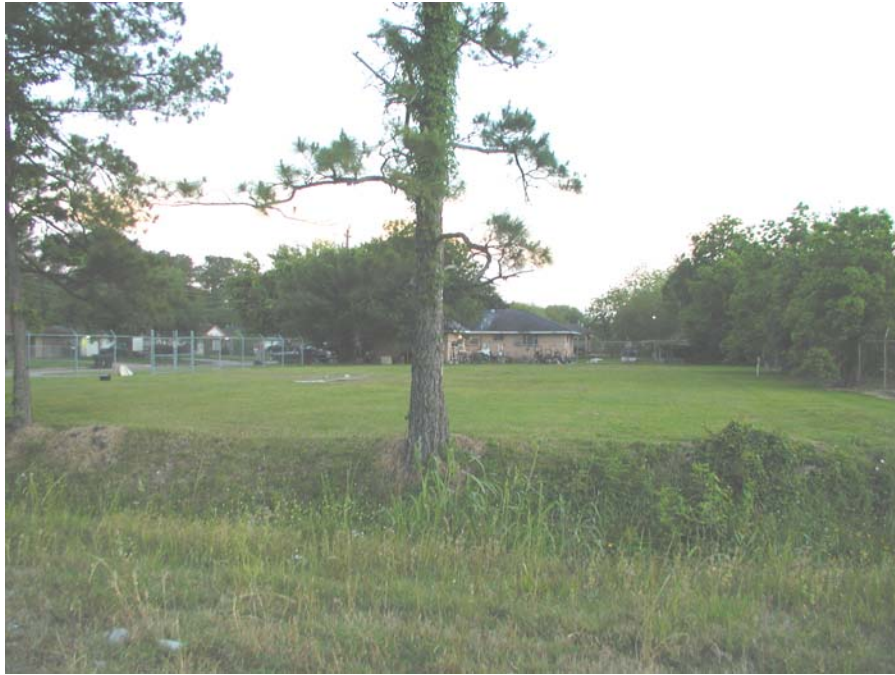
Looking south across subject property from Annunciation

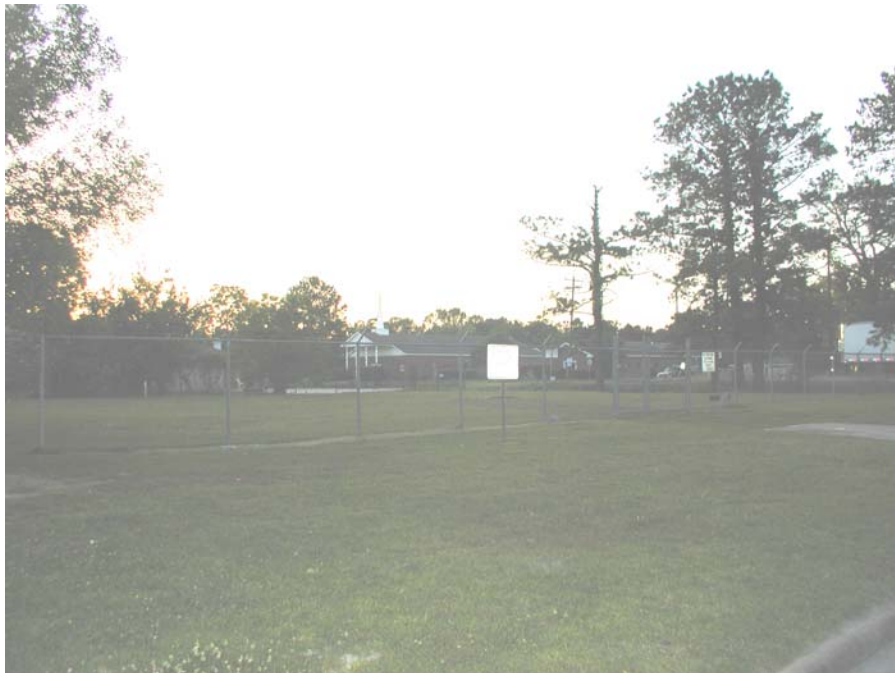
Looking west across subject property from Dalebrook

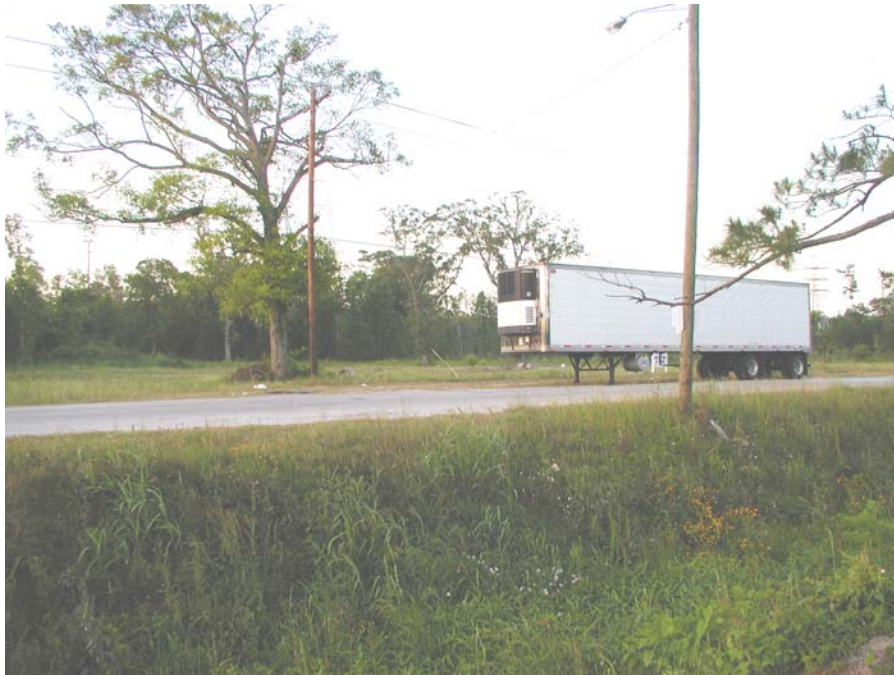
Looking north from subject property.

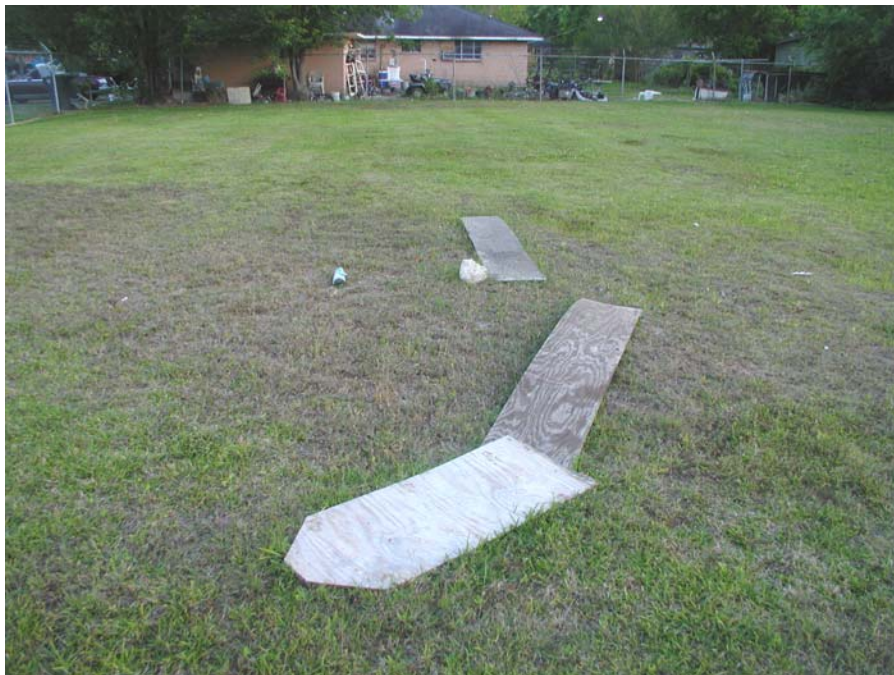
During the site investigation, no containers or drums were observed in the accessible areas of the building. Small amounts of debris are scattered throughout the site. This debris does not appear to be a potential for environmental concern. However, the debris should be properly disposed in accordance with federal, state and local guidelines.

Construction Debris on subject property.

Hazardous Material Use, Handling & Storage During the site investigation, no containers, drums, and hazardous substance or petroleum products were observed. Small amounts of debris are spread throughout the site. It is recommended that these areas be cleaned up and disposed in accordance to federal, state and local guidelines.
